LOW CYCLE COMPRESSIVE FATIGUE
FAILURE OF E GLASS-EPOXY COMPOSITES

Gerald Sedor
Rodney K. Watterson

MASSACHUSETTS INSTITUTE OF TECHNOLOGY
AEROELASTIC AND STRUCTURES RESEARCH LABORATORY

March 1972

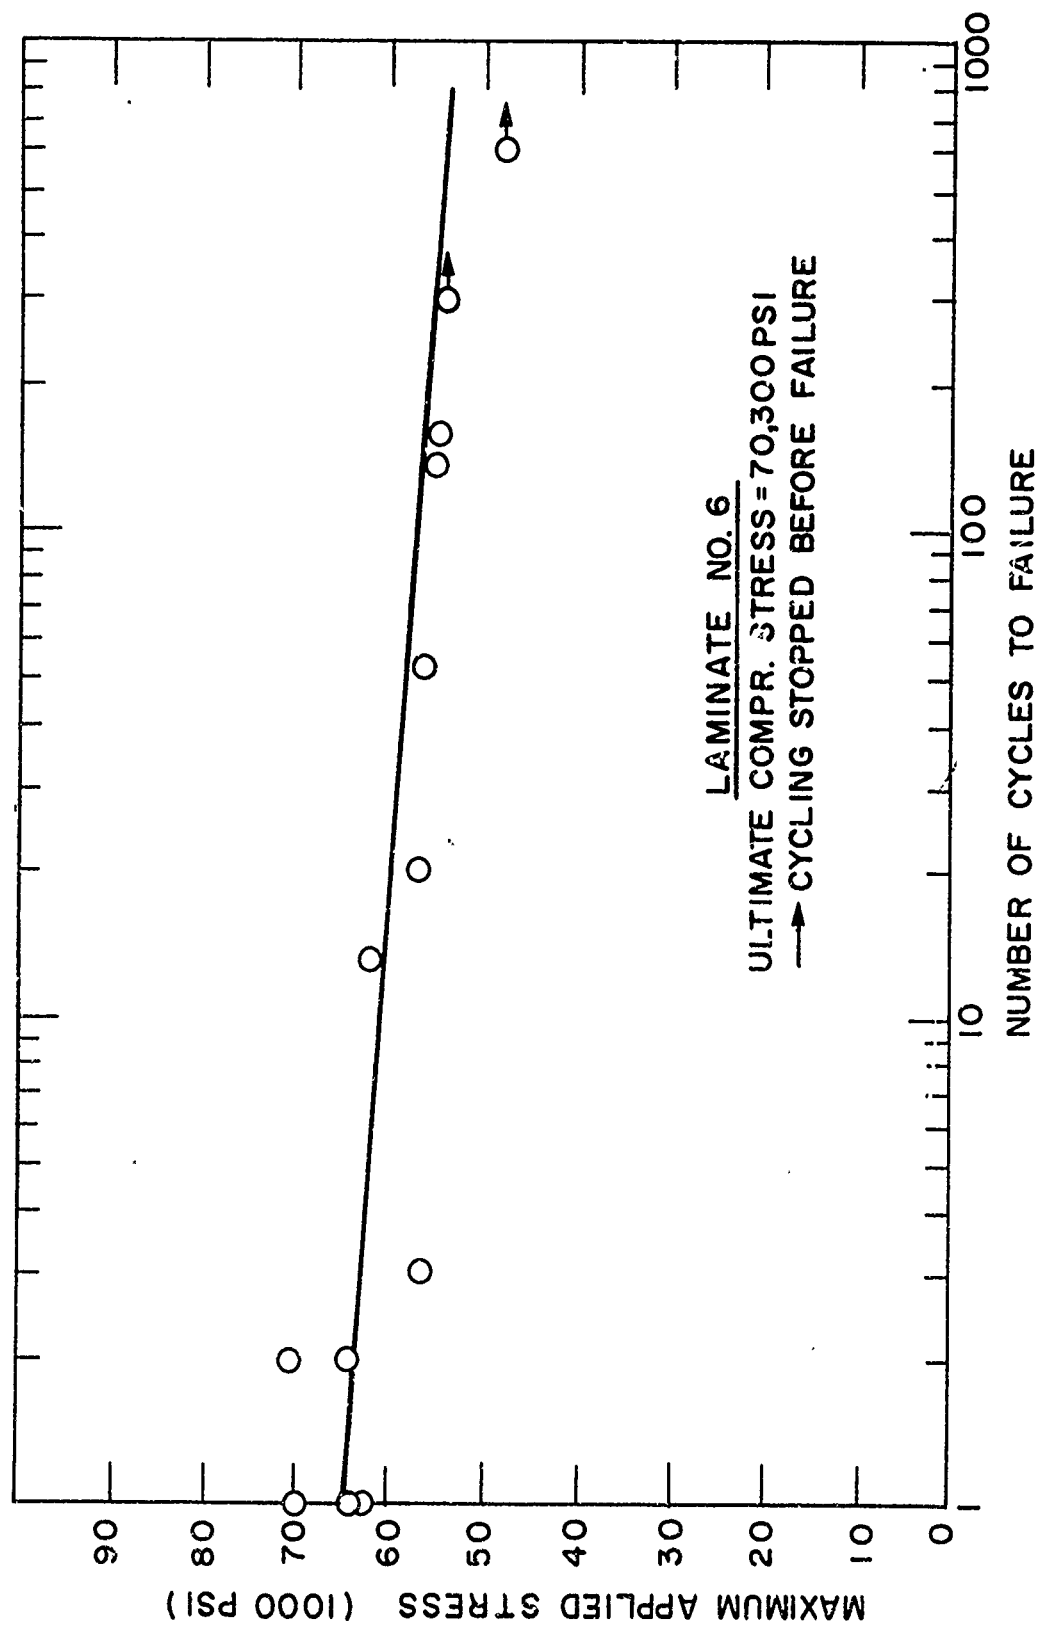
Figure 4 S-N Curve for Compressive Fatigue Test of Laminate 6

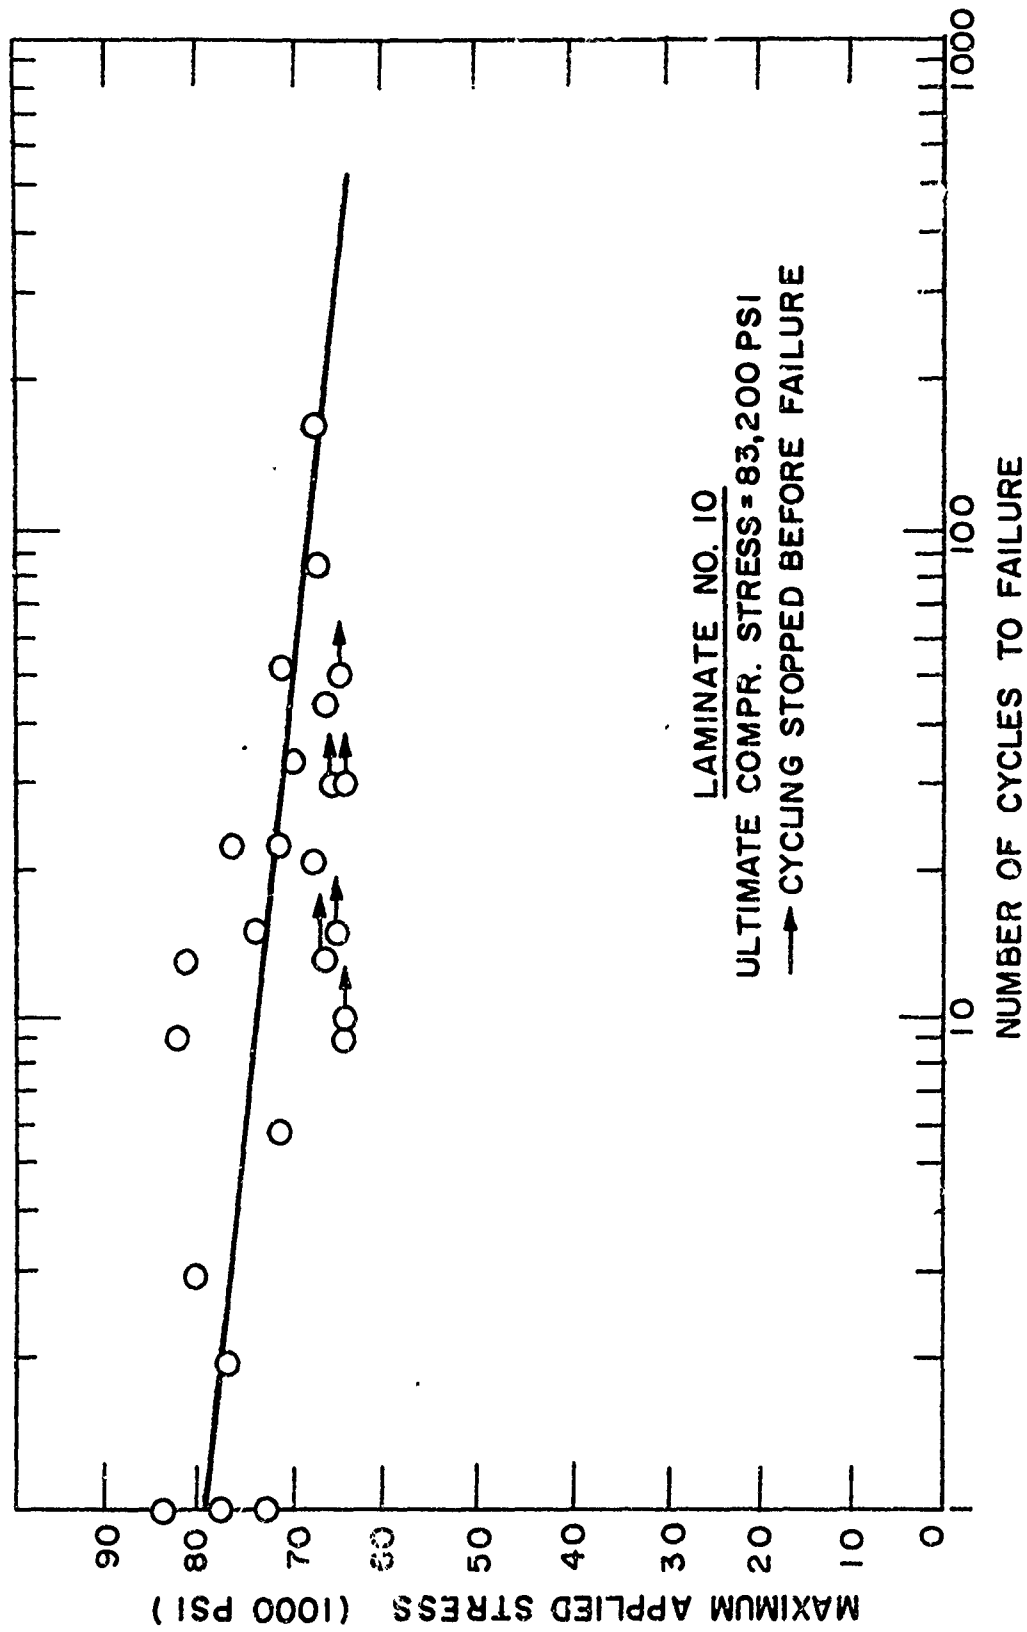
Figure 5. S-N Curve for Compressive Fatigue Test of Laminate 10

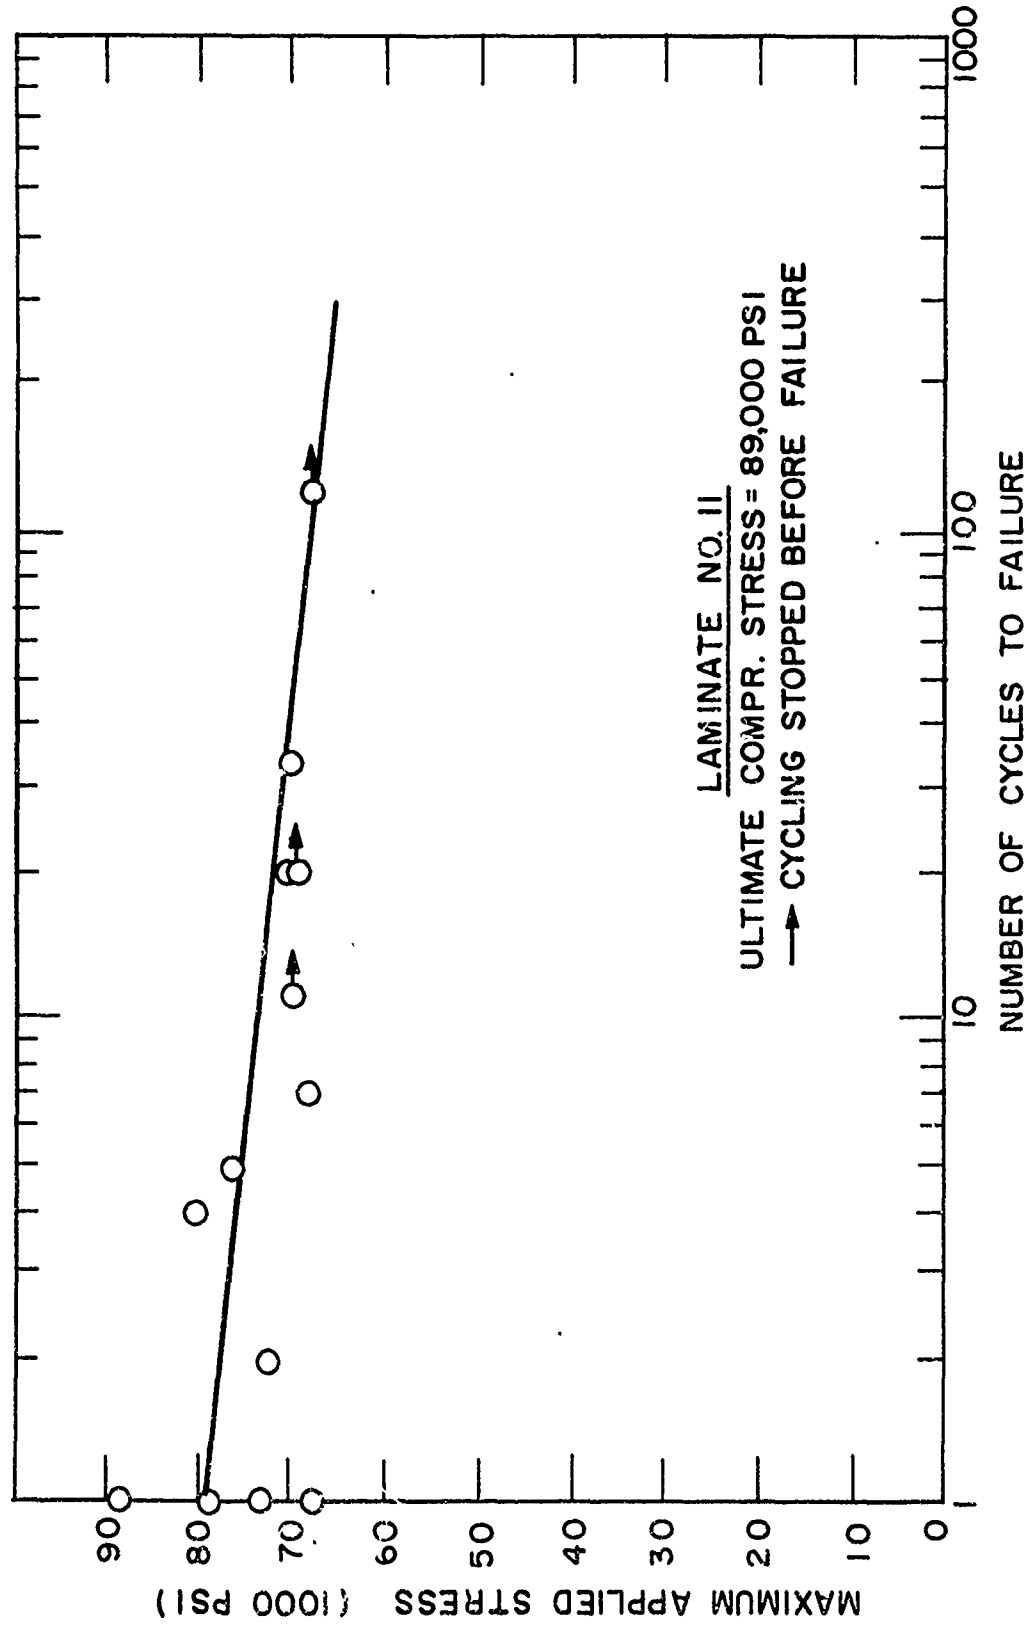
Figure 6. S-N Curve for Compressive Fatigue Test of Laminate II.

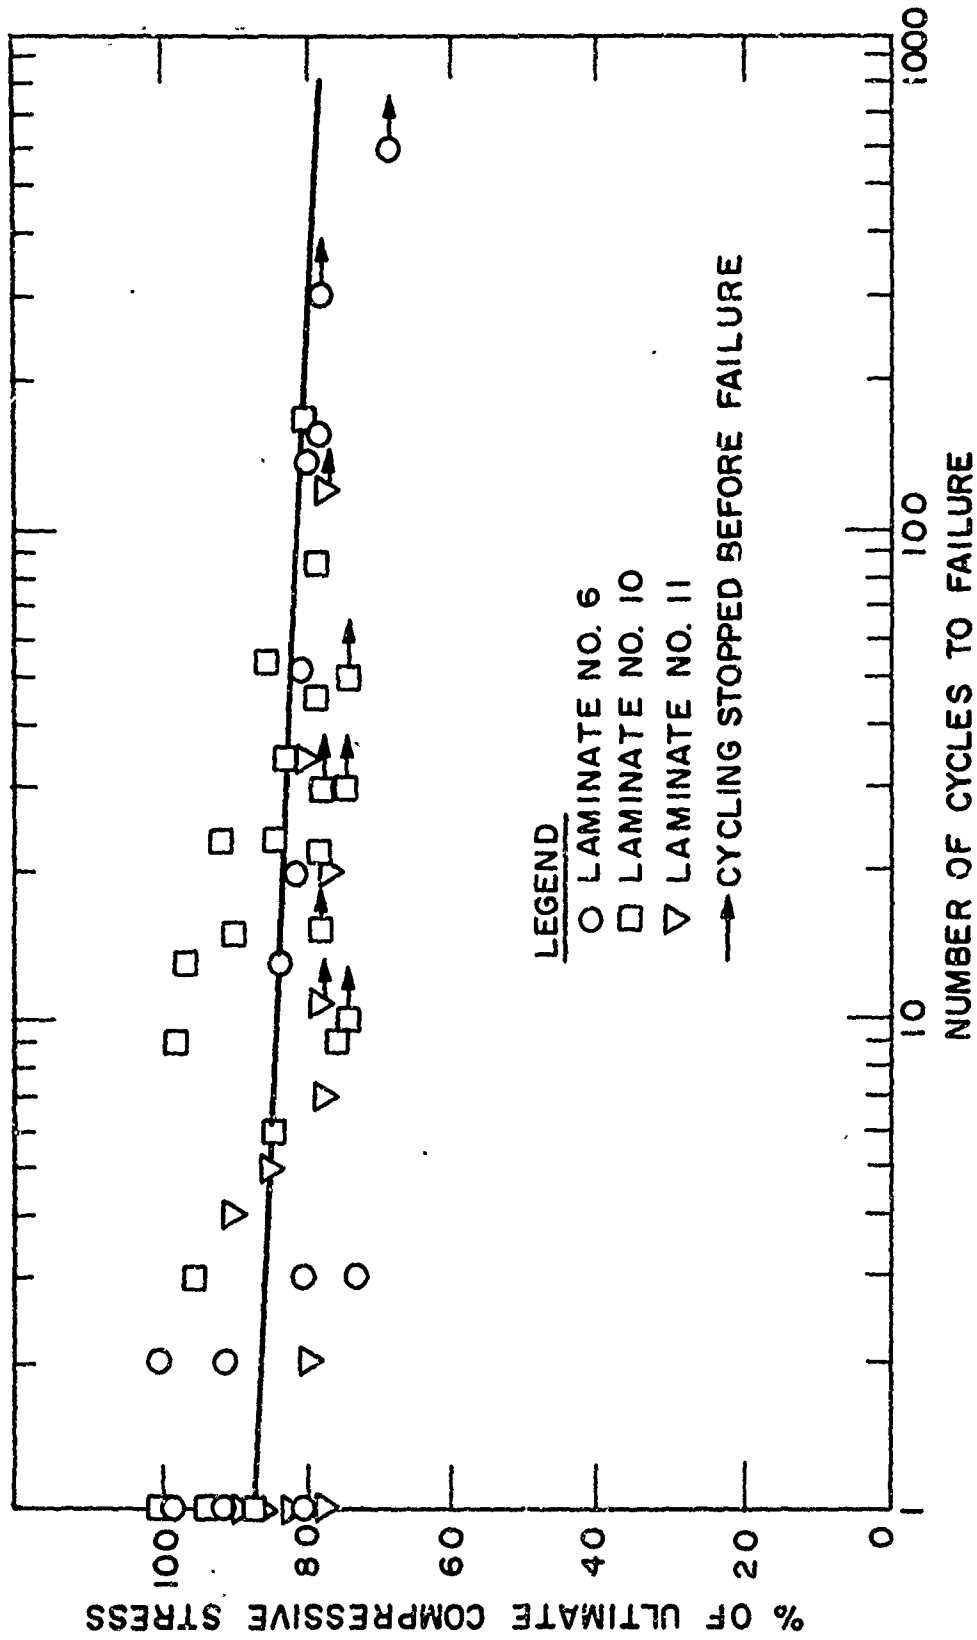
Freund and Silvergleit [12] concluded that a percentage of ultimate concept exists in compressive fatigue of similar materials wherein the applied fatigue stress, as a percentage of true ultimate static stress, can be used in reliably predicting the fatigue life of glass reinforced plastic material. They also indicated that the S-logN curve for glass reinforced plastic is linear for a fatigue stress above 60 percent of ultimate uniaxial compressive stress. Figure 7 supports these conclusions.

Figure 7. Combined S-N Curve for Compressive Fatigue Tests of Laminates 6, 10, and 11.

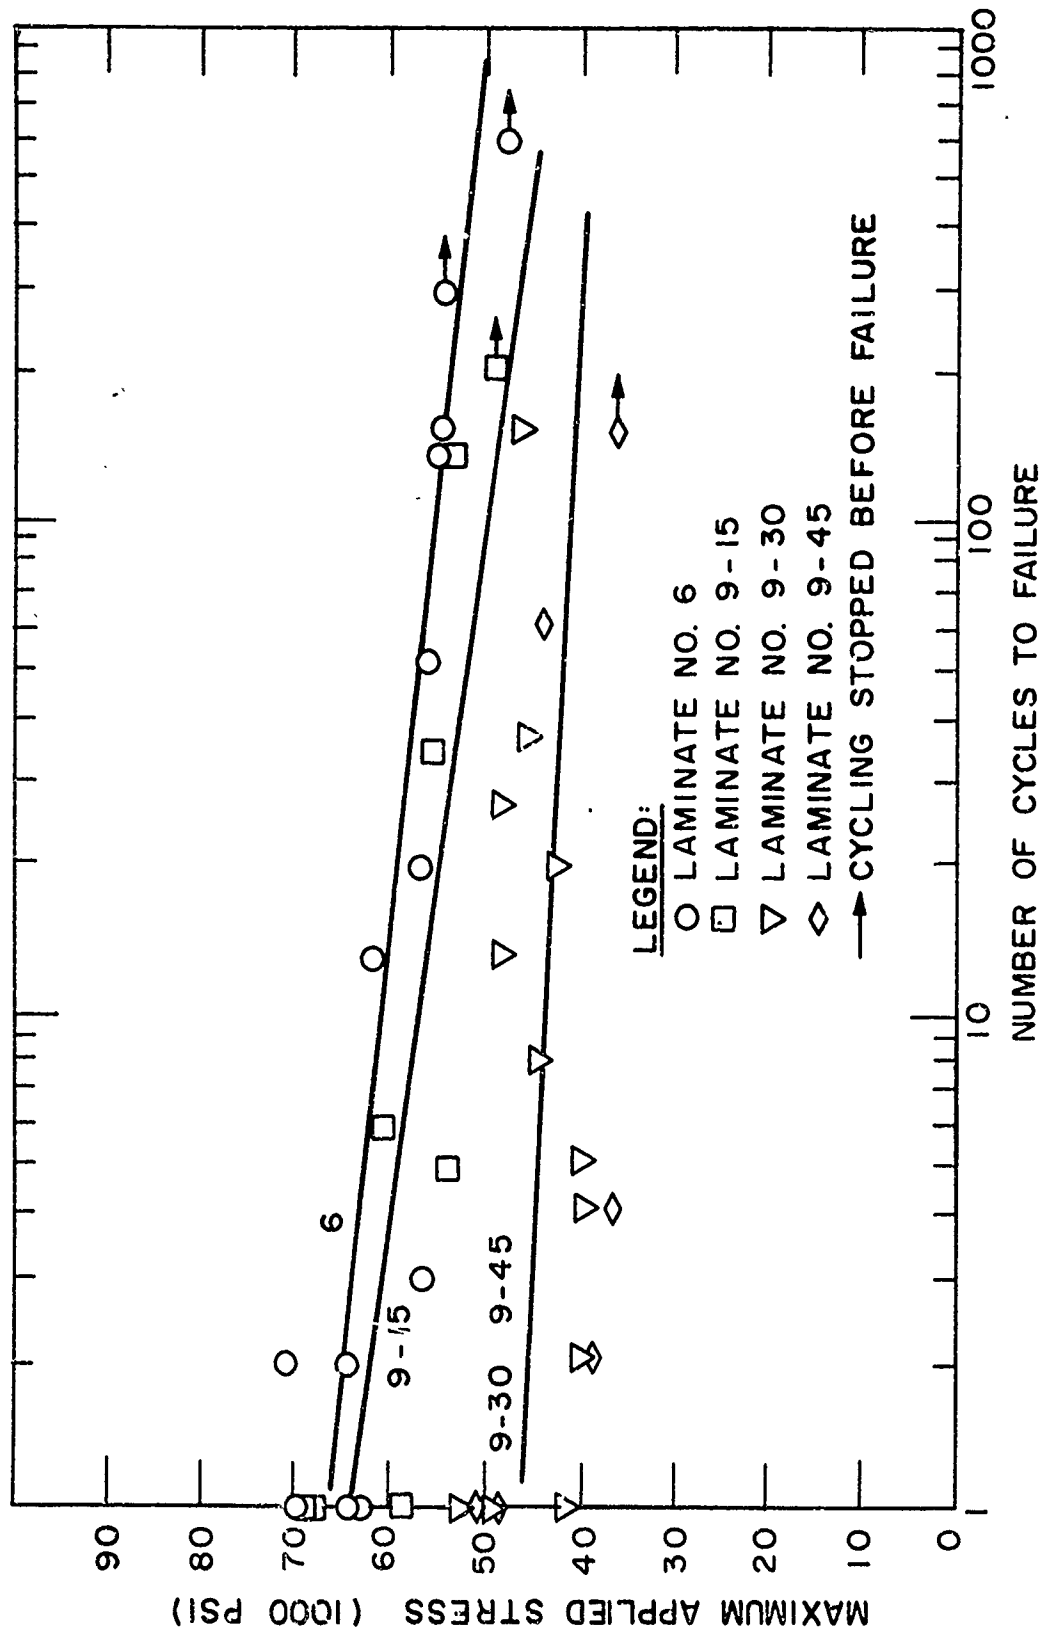
Figure 8. S-N Curves for Compressive Fatigue Tests of Misaligned Laminates 9. Laminates 6 Data Included for Reference

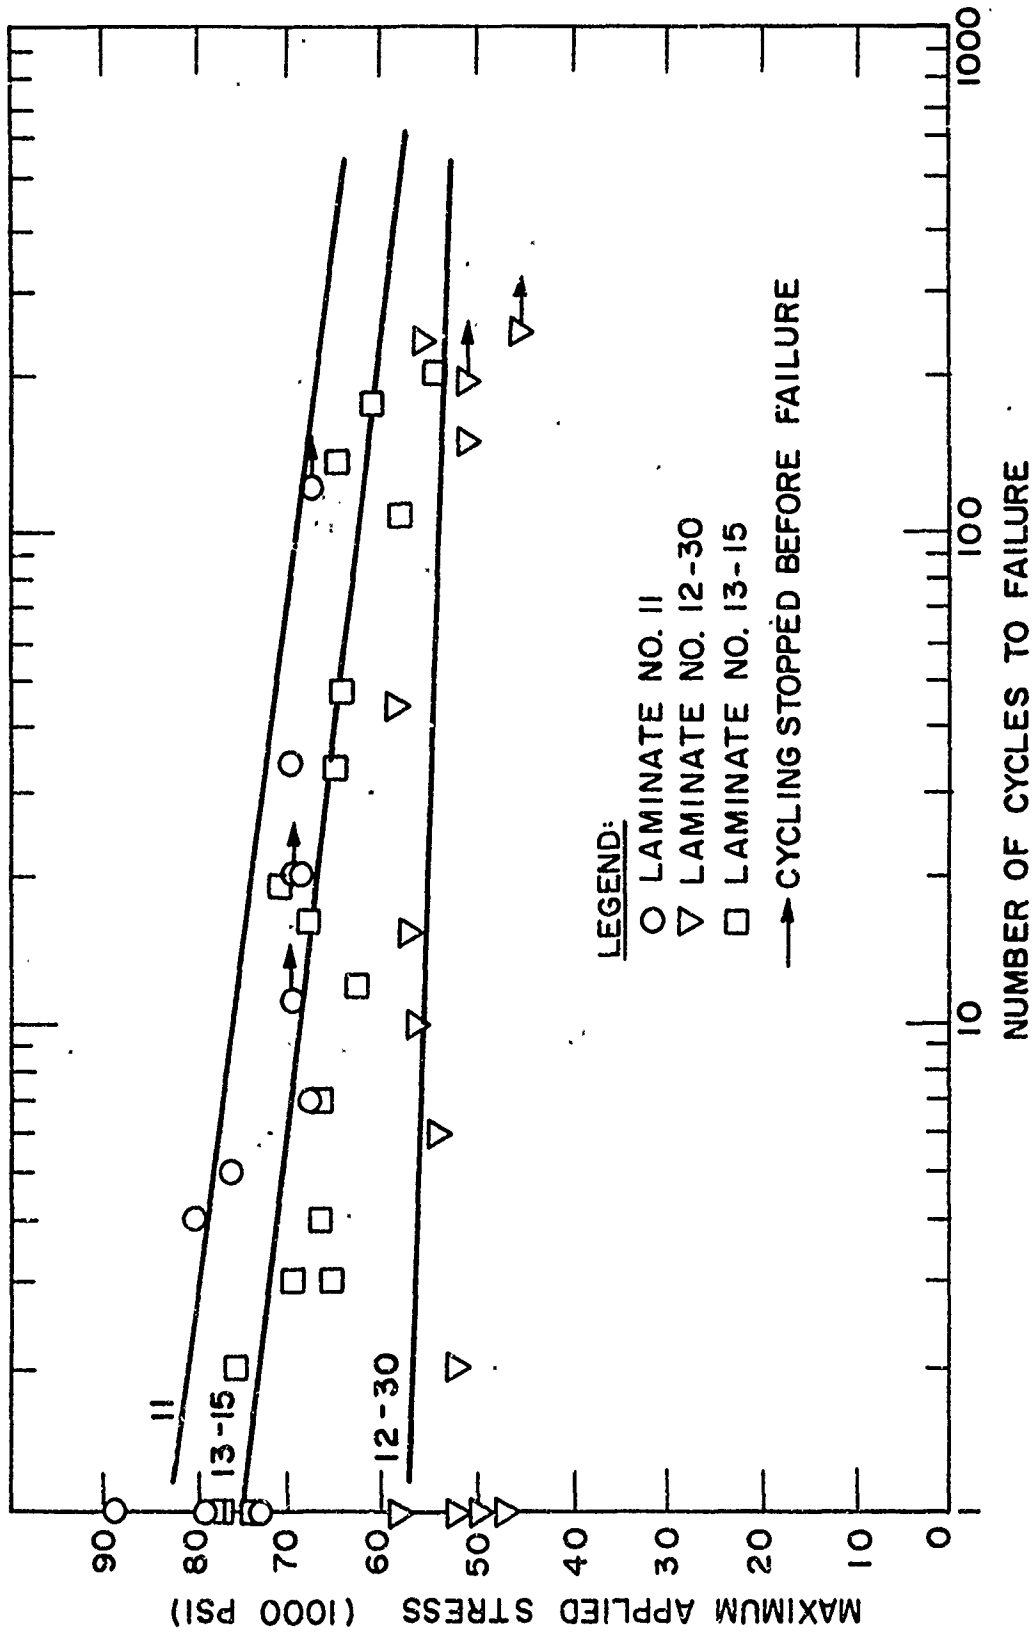
Figure 9. S-N Curves for Compressive Fatigue Tests of Misaligned Laminates 12 and 13. Laminate 11 Data included for Reference

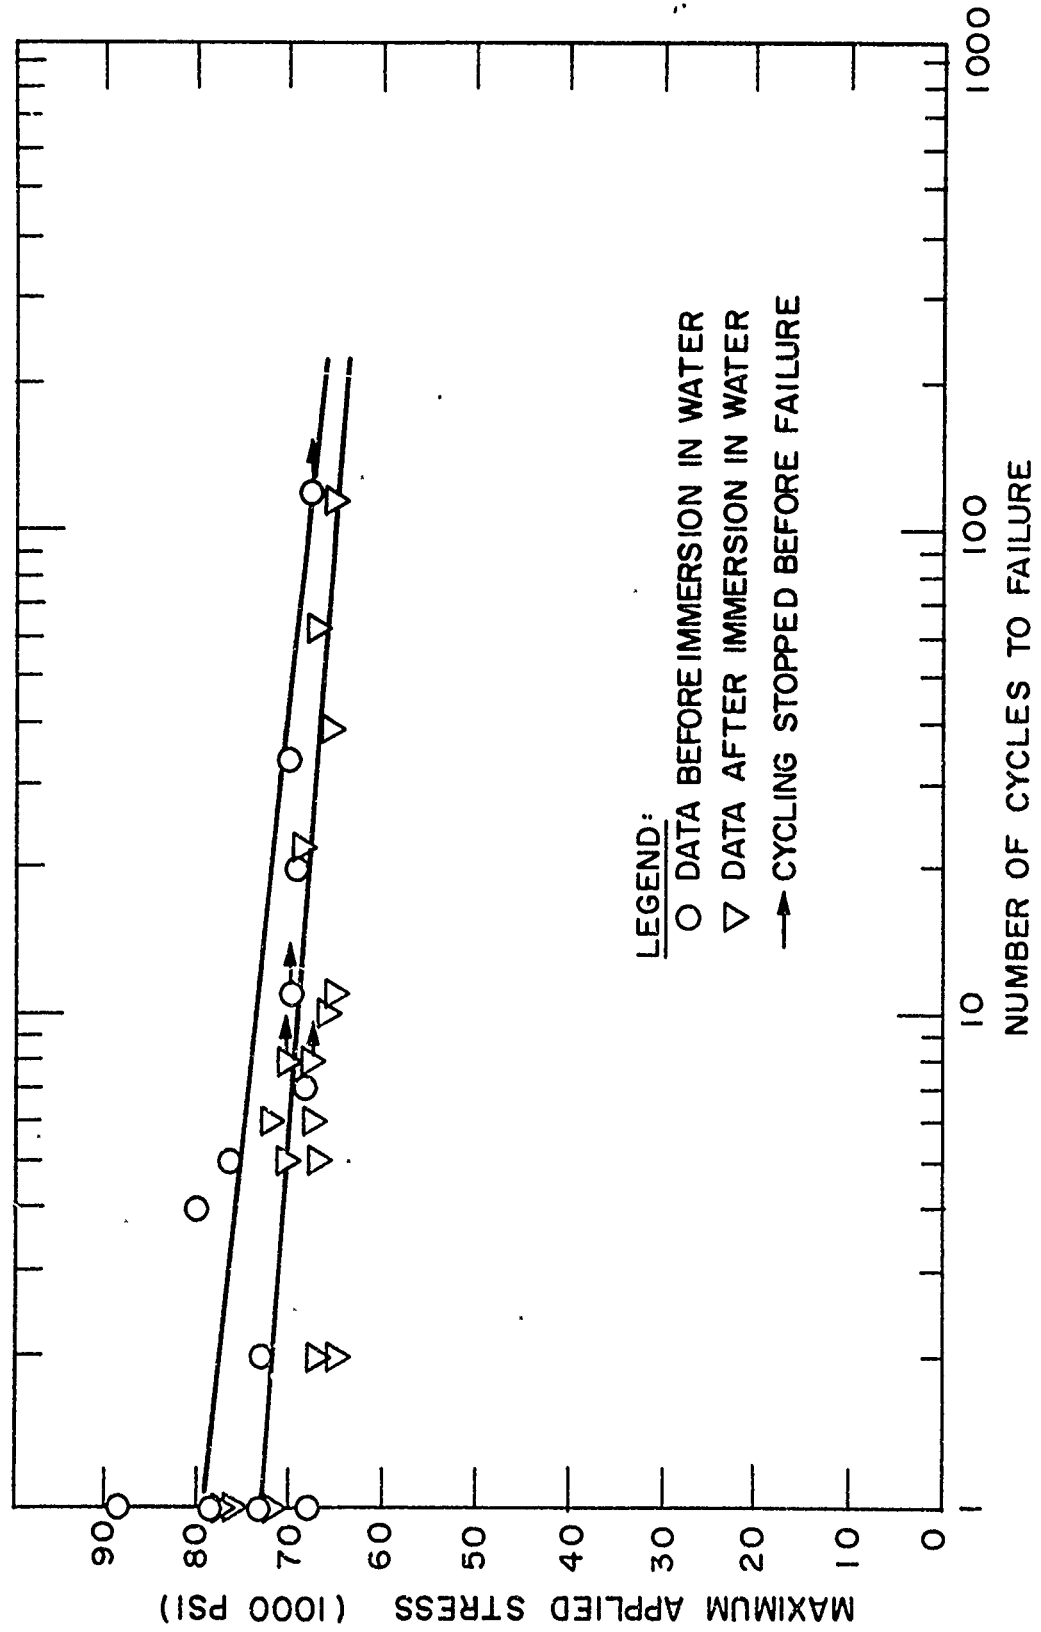
The results of testing Laminate 11 before and after sea water immersion are compared in Figure 10. Immersion in sea water for 21 days resulted in an average water absorption of 0.226% by weight. Compressive fatigue strength for the immersed specimens showed a decrease of approximately 6 to 10 percent throughout the range tested, as shown in Figure 10.

Figure 10. S-N Curves for Compressive Fatigue Tests of Laminate II, showing effects of Sea Water Immersion

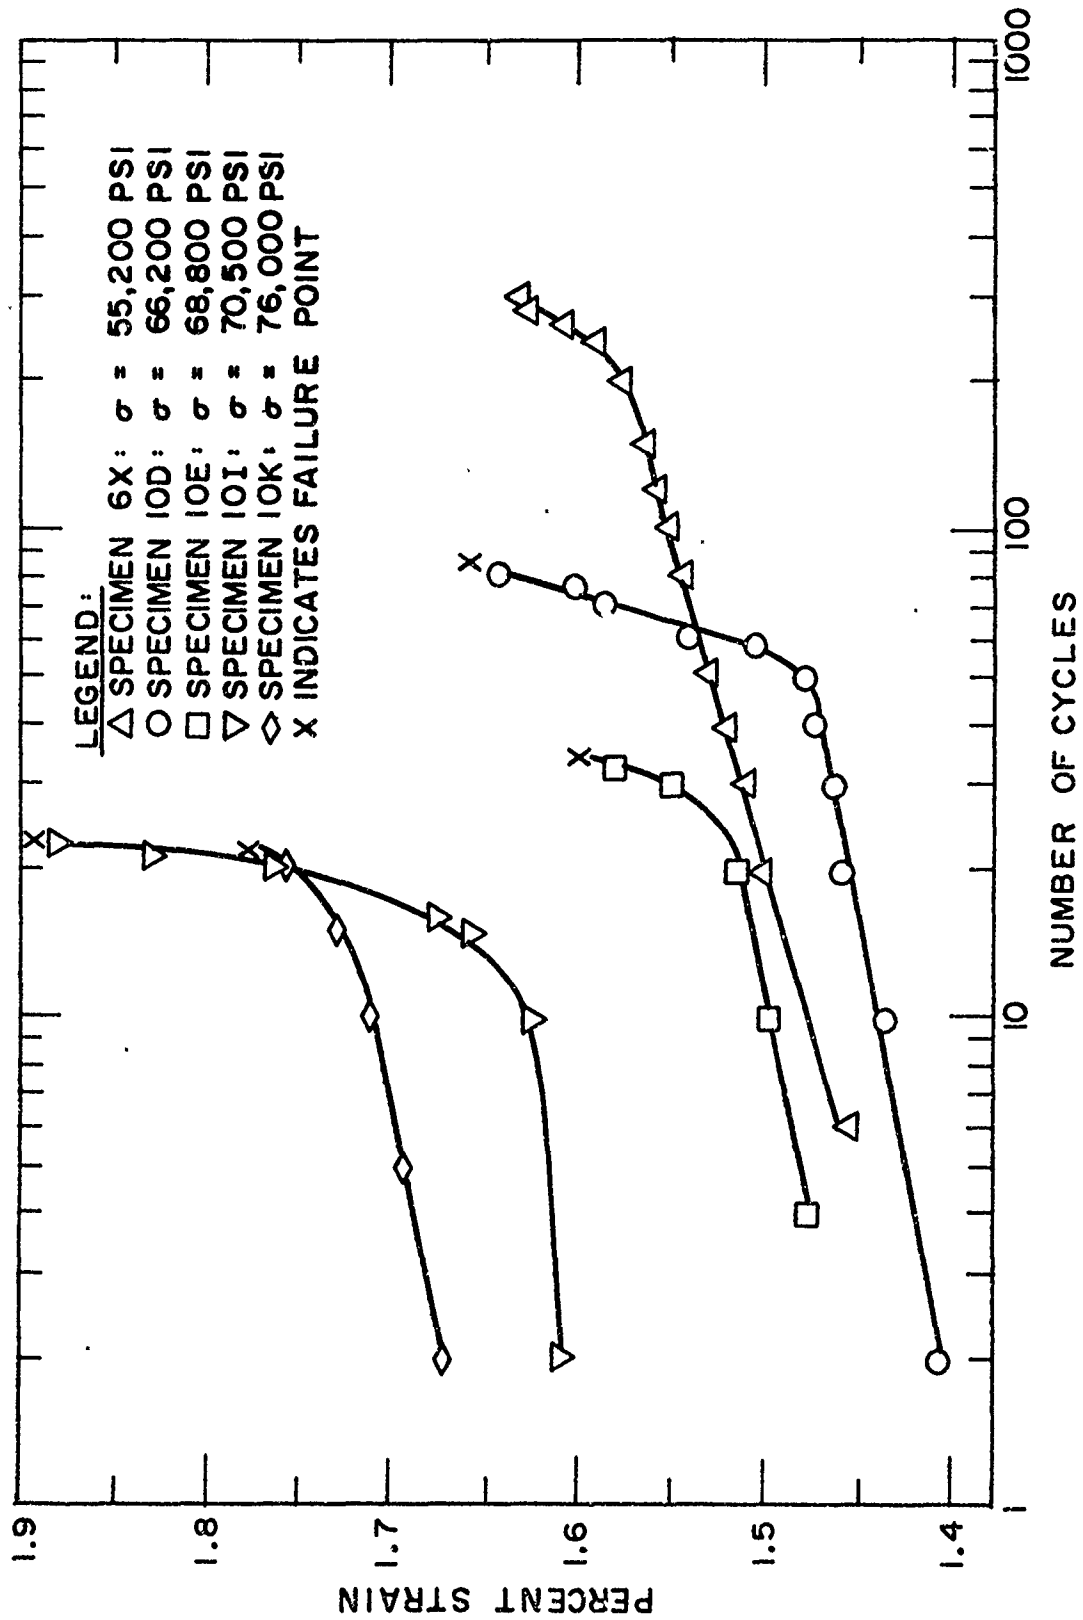
The strain history of the selected specimens, shown in Figure 11, indicates that the strain at maximum stress increases in an almost linear manner up to approximately 60% of the fatigue life of the material. Beyond this point, there is a marked increase in the rate of permanent strain accumulation. A summary of data for fatigue tests can be found in the tables of Appendix B.

The strain history data, plotted for selected specimens in Figure 11 proved to be of value as an indicator of proximity to fatigue failure. The characteristic knee in the curves at approximately 60% of fatigue life is consistent in all specimens tested. It is interesting to note that for Specimen 6X, for which the cycling was stopped prior to failure, the calculated fatigue life based on the knee occurring at the 60% point is in excellent agreement with the S-logN curve for this laminate. It is apparent from the form of the strain history curves that two processes occur in the laminate. The relatively minor increase in strain from 0 to 60 percent of specimen life characterizes a mechanical modulus softening effect, perhaps accompanied by limited void growth and other minor damage. At 60 percent of life, the permanent strain accumulation rate increases significantly, indicating that major damage is now being done.

The strain measurements taken during the fatigue tests add additional insight into the failure process. As indicated in Figure 11, the strain rate appears to be constant with increasing cycles up to approximately 60% of fatigue life. A significant increase in strain rate is found beyond this point. It is proposed that during the first 60% of fatigue life the only significant damage occurring is that of circumferential debonding between individual fibers and matrix within axially aligned plies. This is borne out by Figure 21 in which Specimen 11BK is shown after cycling to somewhat less than 50% of expected fatigue life. No damage is apparent within the plies or at the interlaminar surface.

Figure 11. Strain History of Selected Specimens During Compressive Fatigue Testing, Showing Sudden Increase in Strain Accumulation Rate at Approximately 60% of Fatigue Life
